## Safety Bulletin – Nitric Acid Container Failure

### 1. Overview of Incident

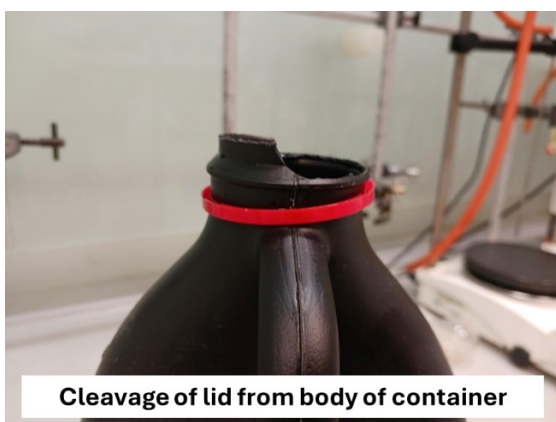
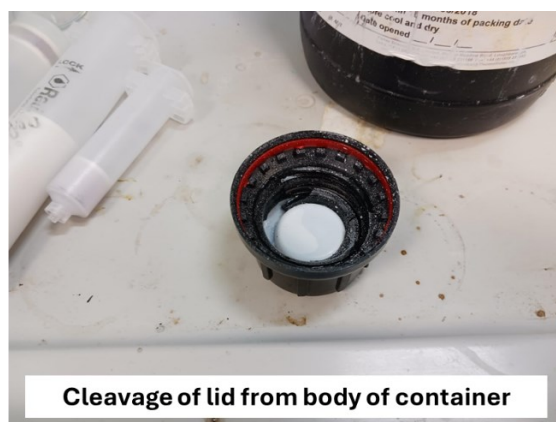
A researcher was moving a bottle of concentrated nitric acid housed within a storage cabinet. Whilst looking for another reagent, the researcher tilted the bottle of nitric acid to one side while supporting the cap with their hand. Suddenly, the top of the bottle sheared and detached from container body resulting in the acid spilling.

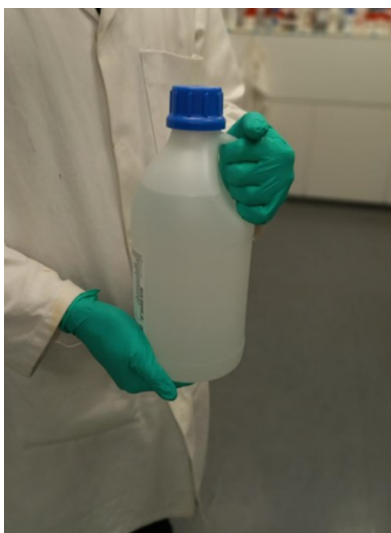
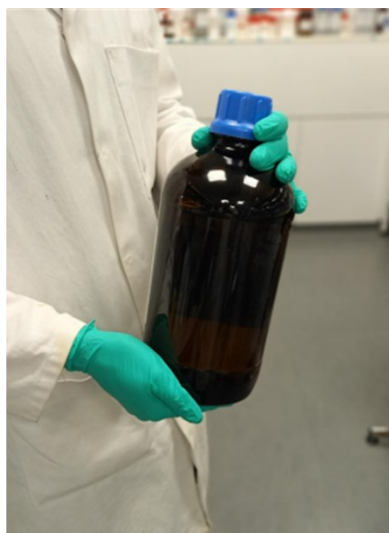
Whilst the researcher was only supporting the top of the container with their hand when the container failed, the incident serves as a reminder not to lift bottles / Winchester bottles solely by their lid / cap. Handles should be used where available whilst supporting the body of the container with the other hand.
