Overfilling Waste Containers

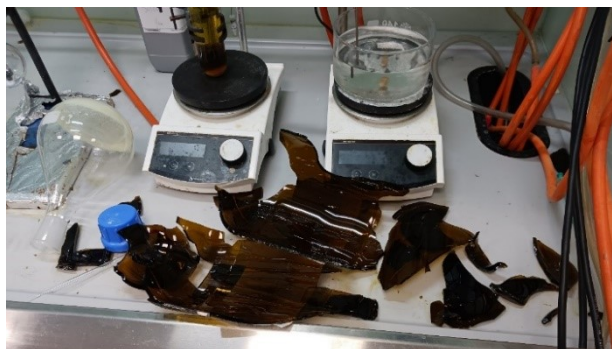
Two glass Winchesters were filled to the brim with waste dichloromethane (DCM). After ~2 hours, the Winchesters ruptured spilling their contents across a fume cupboard and surrounding area.

An investigation found the waste DCM had come from the collection flask of a rotary evaporator and added to the Winchester when cold (estimated 5 °C). It is believed that the expansion after the solvent reached room temperature was sufficient to cause the containers to fail.
